Cal-OSHA Consultation
ATTN: Eric Berg
Acting Principle Safety Engineer

Sub-4. CSO - Article 29. Erection and Construction - §1712. Reinforcing Steel and Other Similar Projections section (c) Protection from Reinforcing Steel and Other Similar Projections.

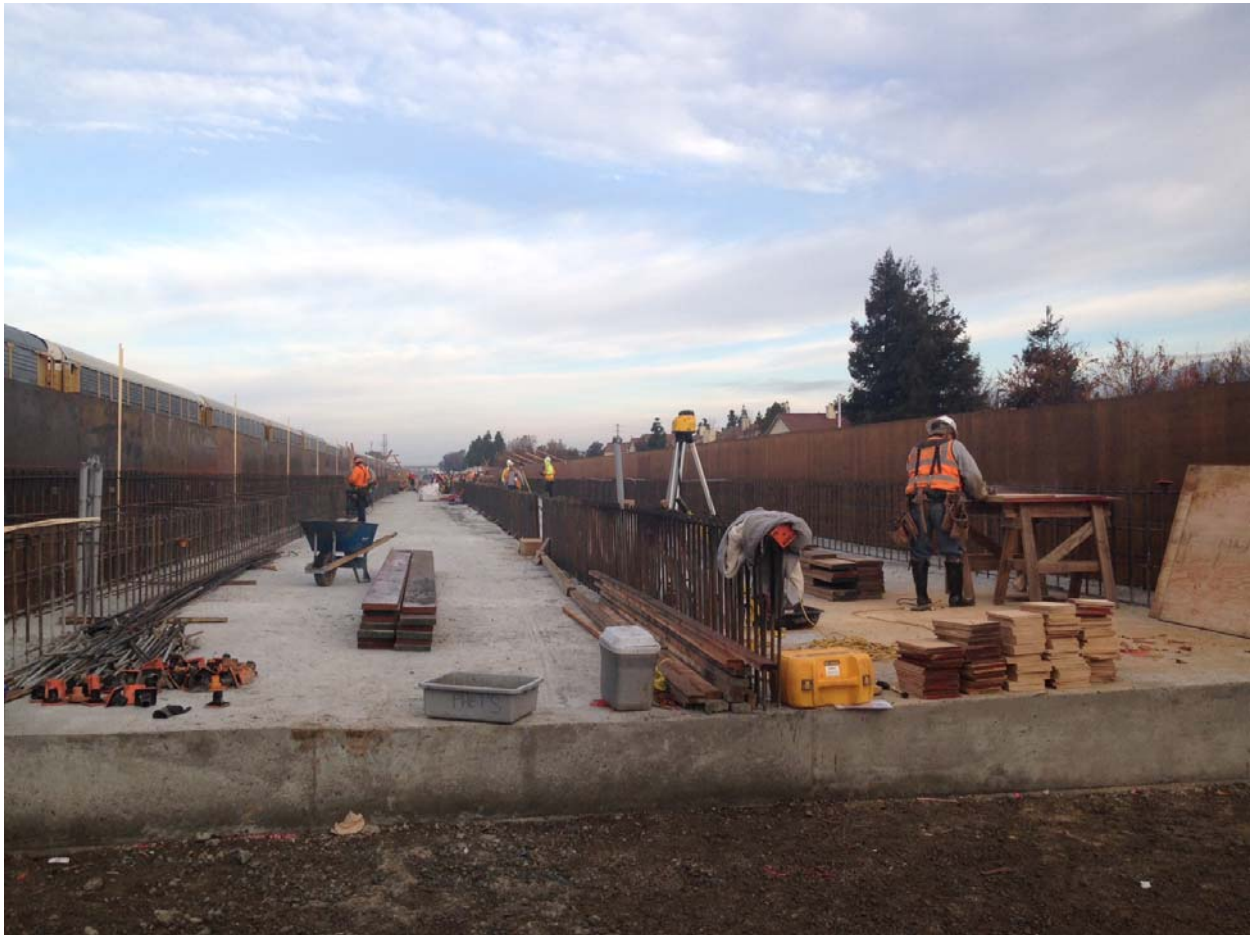
Missing impalement protection on vertical rebars. Contractor had stated that a top horizontal bar was considered adequate protection. Is this condition considered a work in progress?

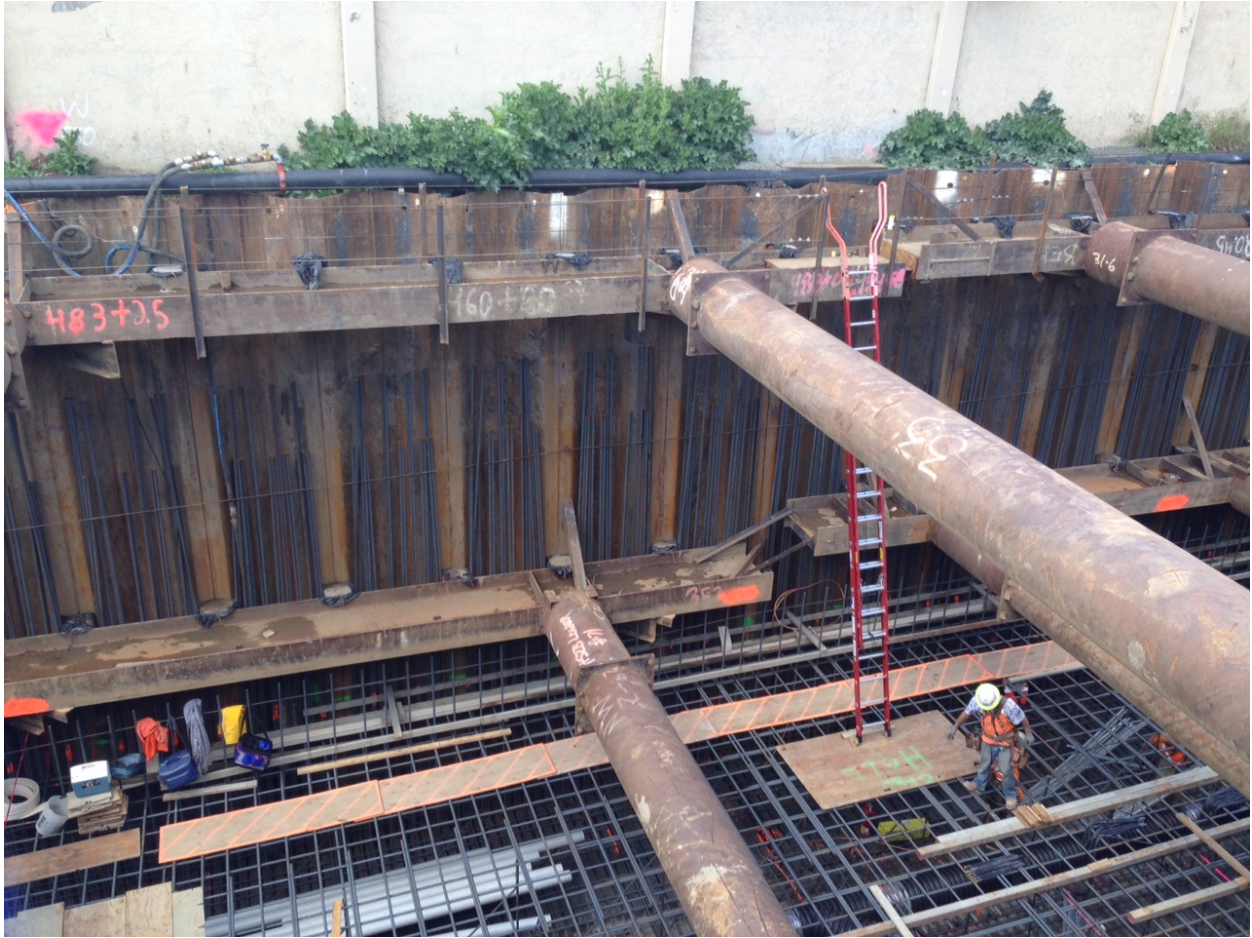
Unprotected vertical rebar next to an active temporary walkway

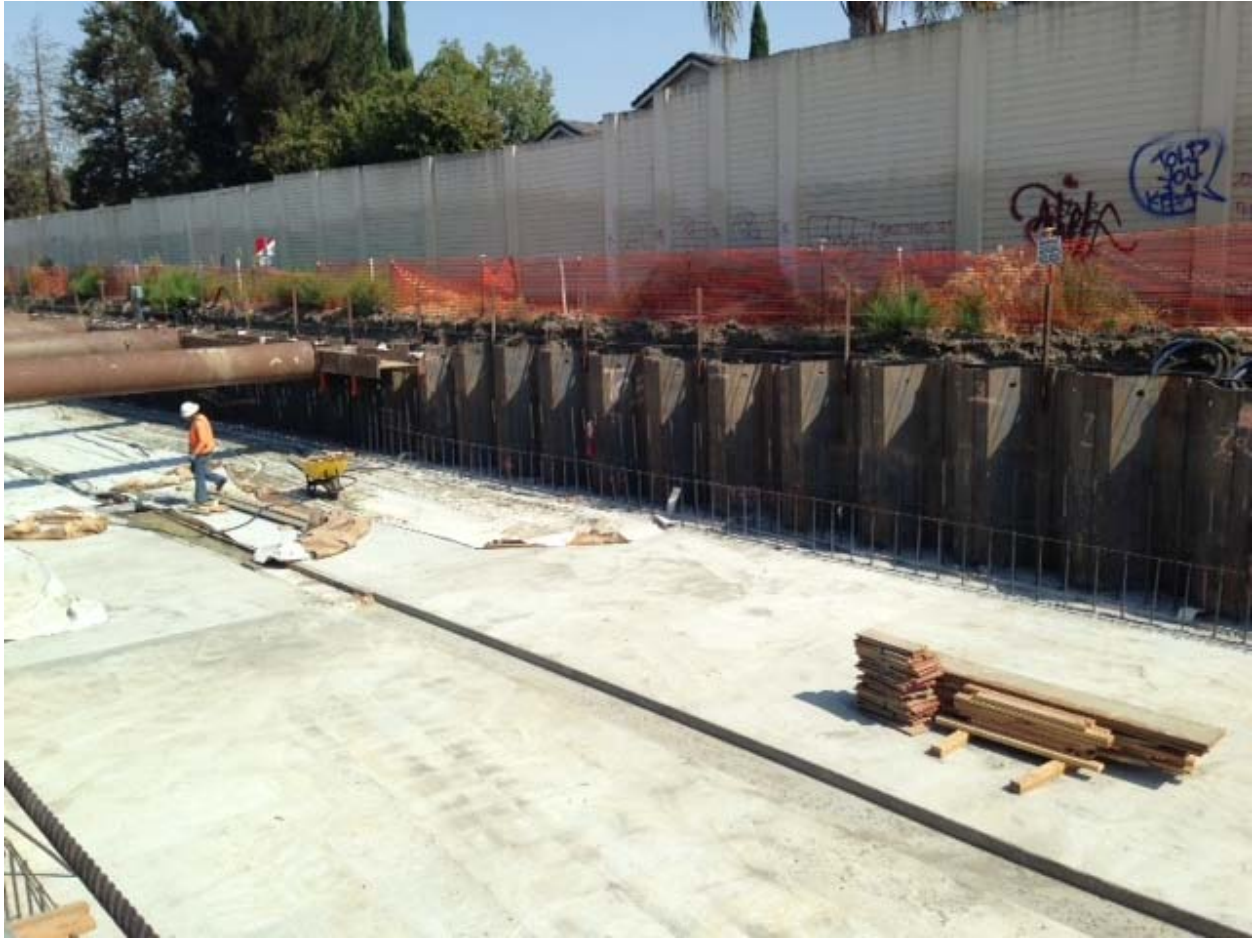
Another location where impalement protection is not provided. Concrete Masons were exposed to unprotected vertical rebar during the casting of this section of slab.

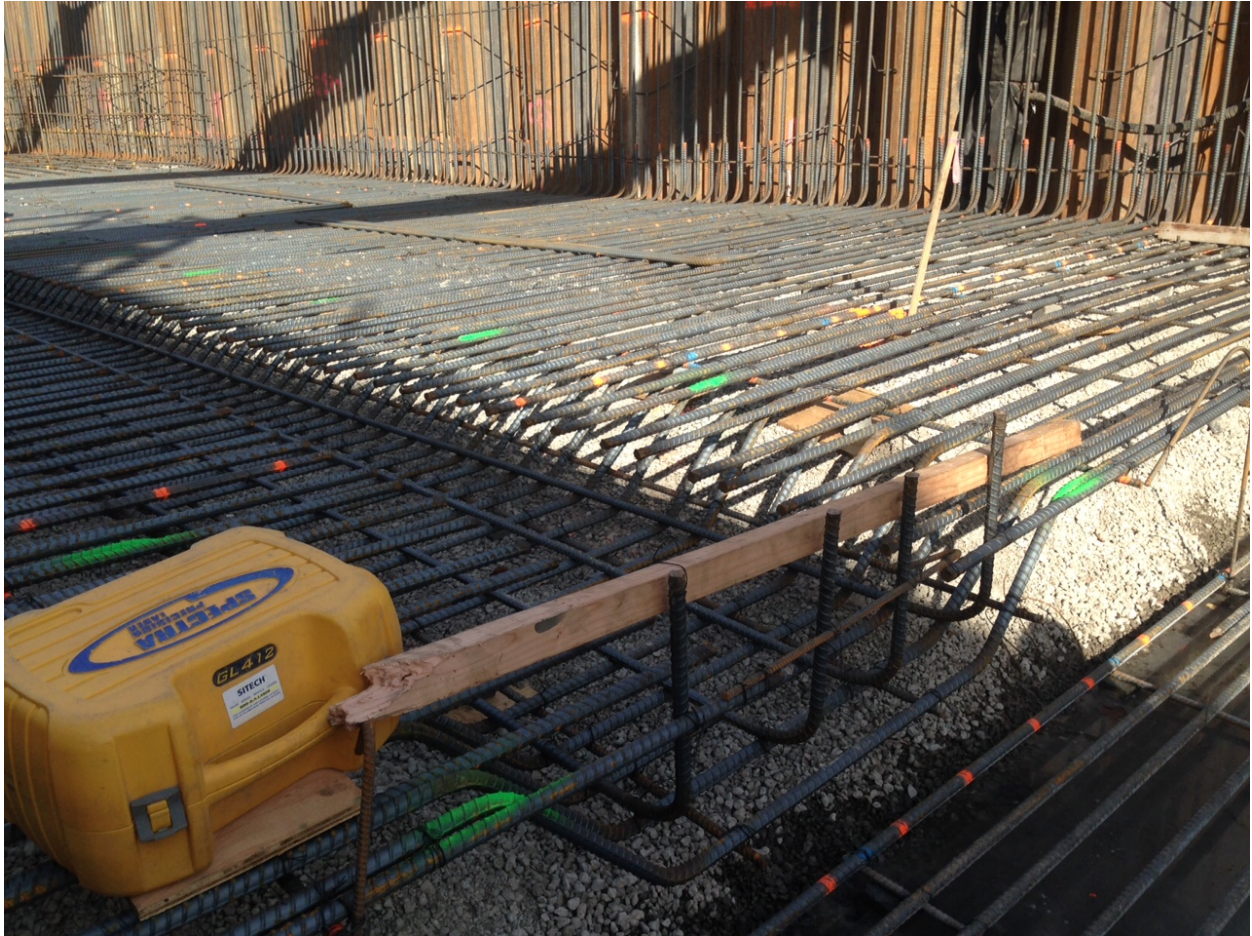
A 2X4 is tied alongside the tails of these rebars as a form of impalement protection. Is this compliant?

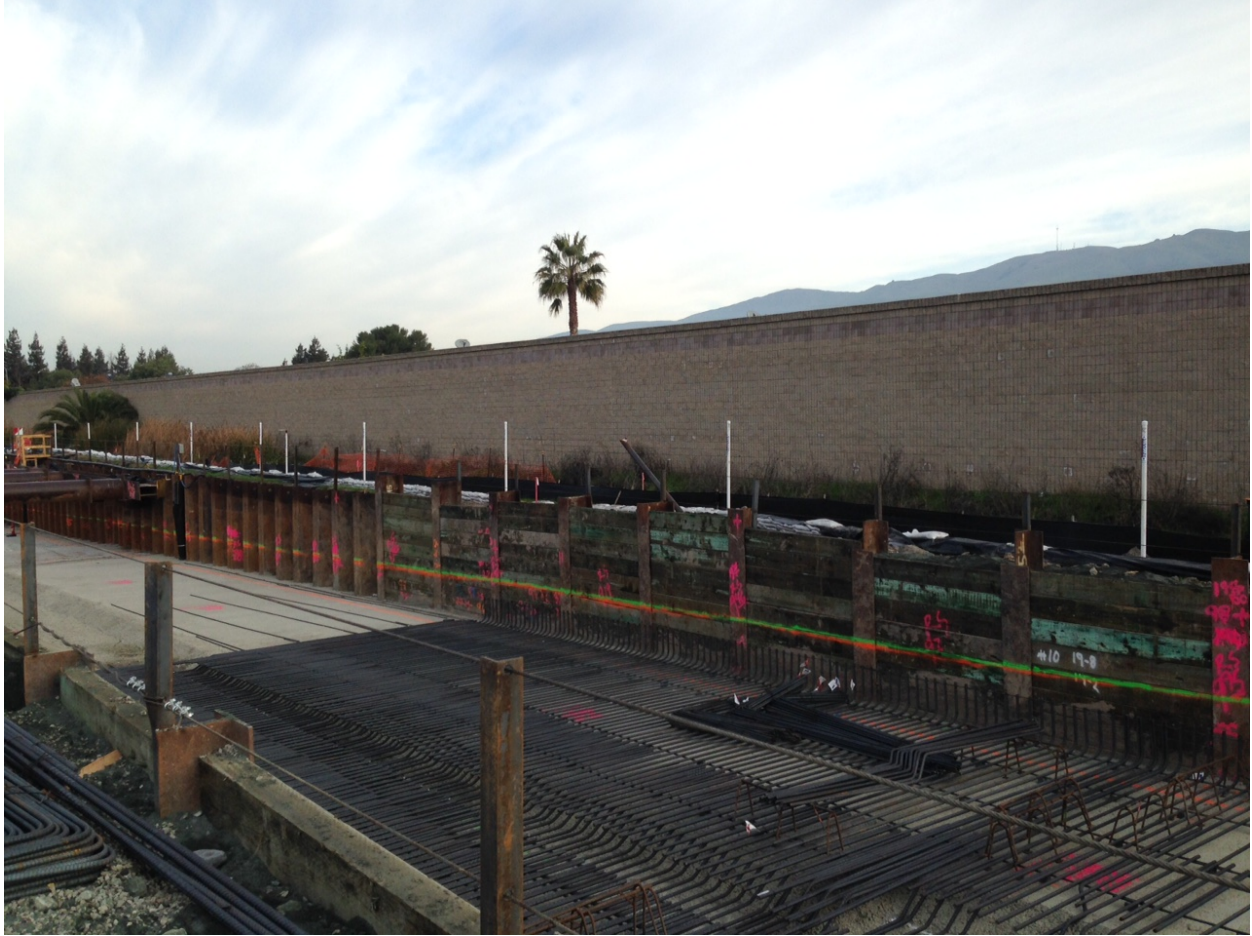
An inactive work area and rebars were left unprotected. Is this considered a work in progress if the area is not barricaded off and work will not resume due to lack of materials due to deliveries?

Is this area in compliance with regulations?

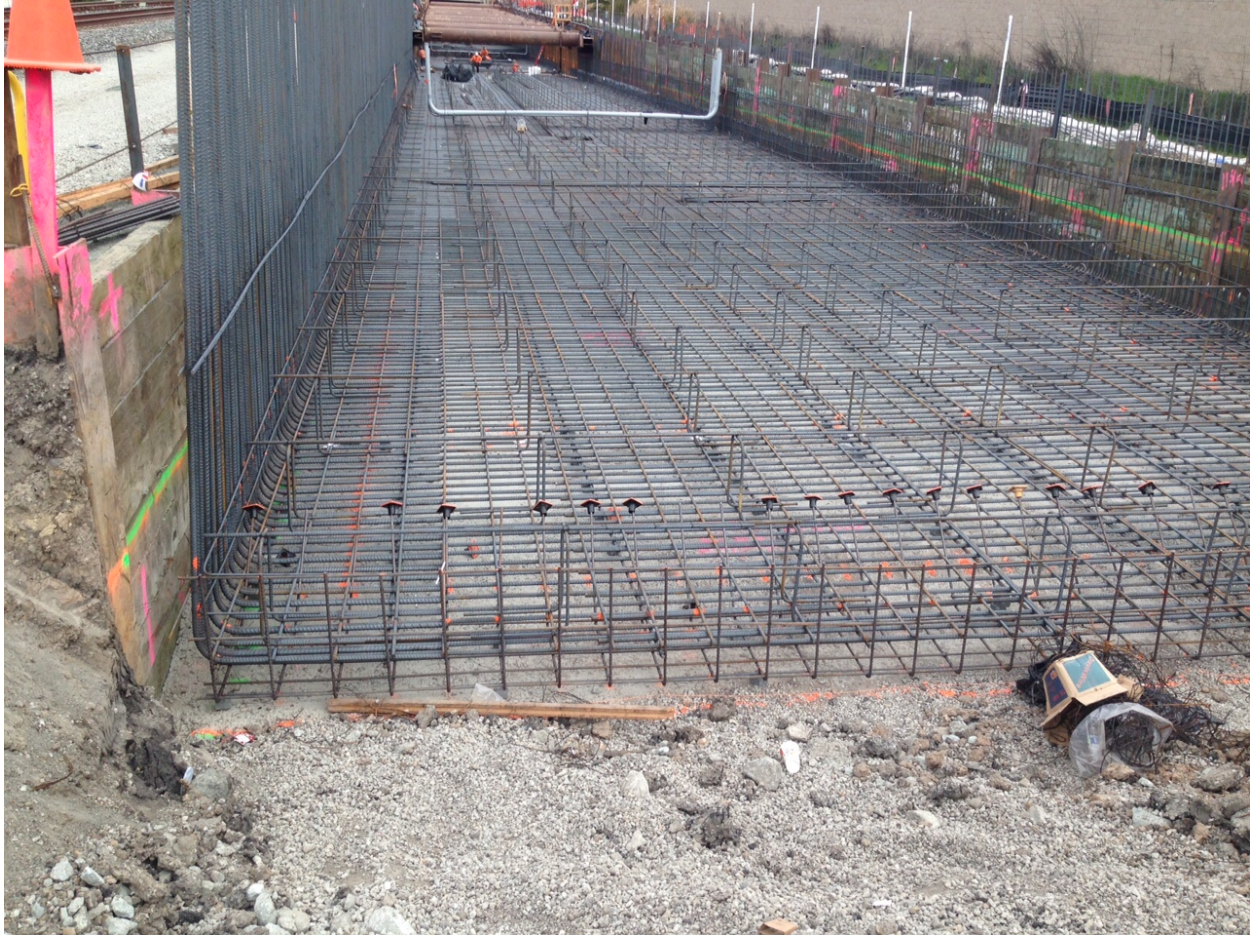
Installers worked out of this area and the rebars were not protected leaving impalement exposures to others that access from this area. Is this considered a work in progress and protection not required.

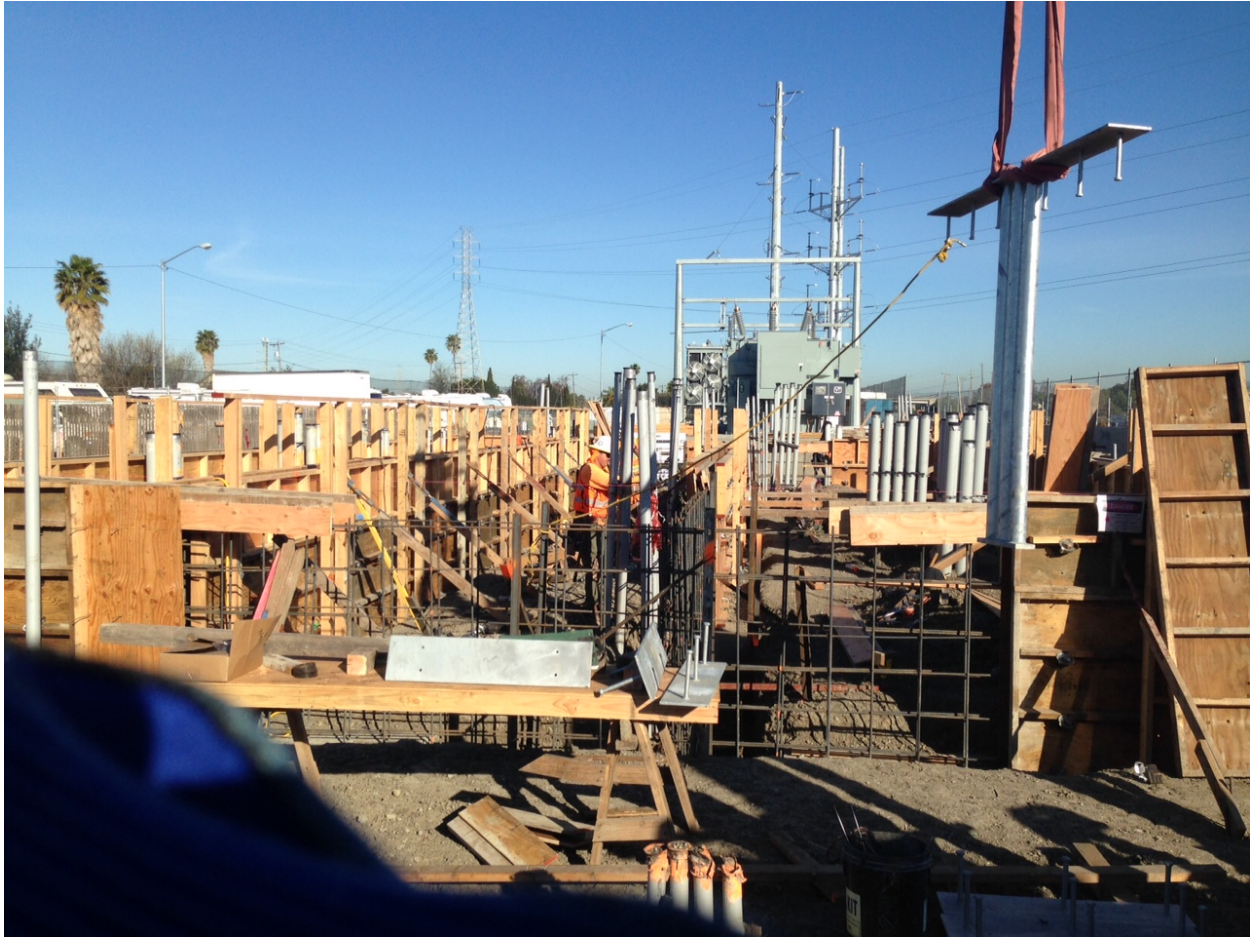
Workers are only partially protecting vertical rebars in the active work area.

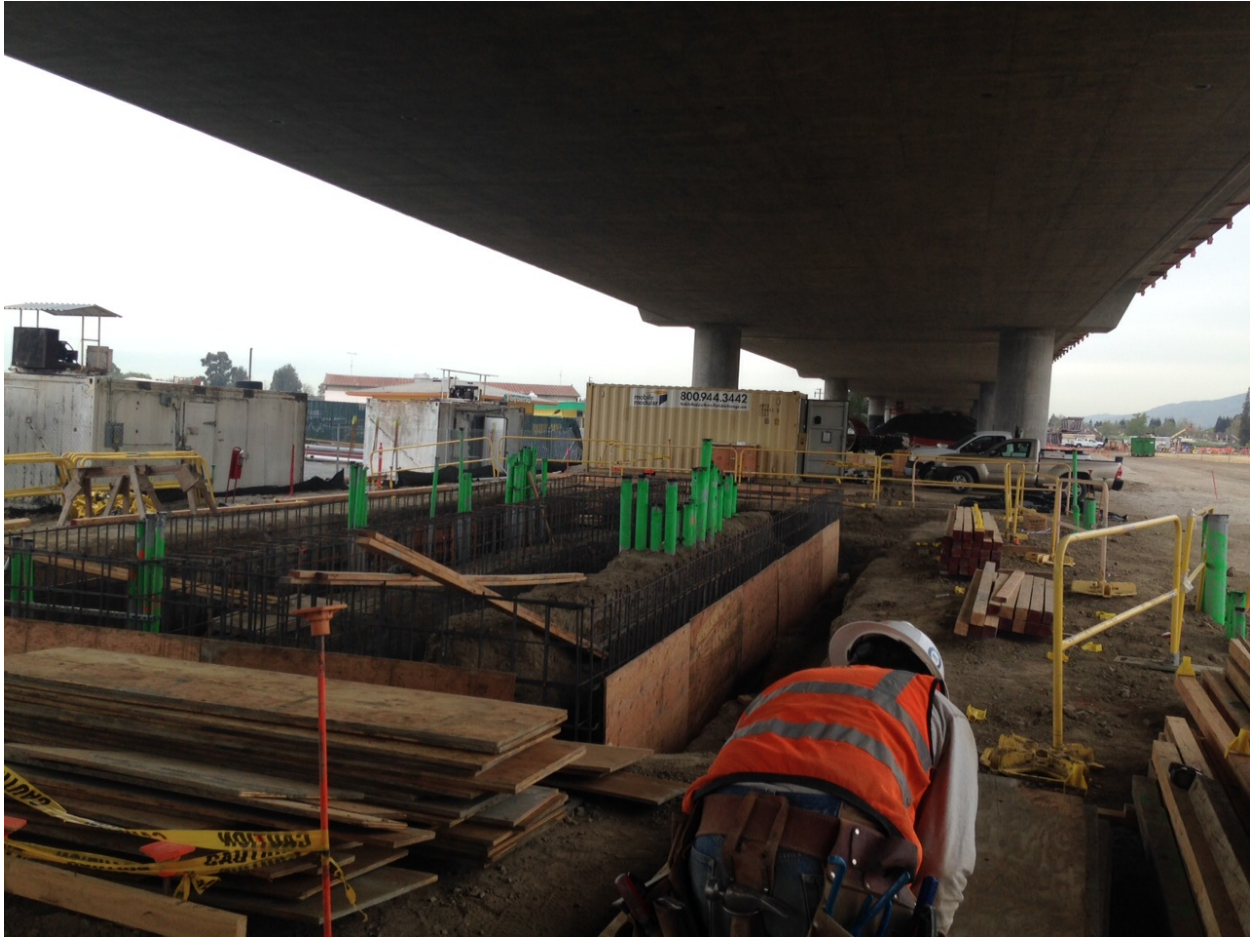
Carpenter crew did not install impalement protection and are considering the top horizontal bar a compliant means of protecting from impalement.

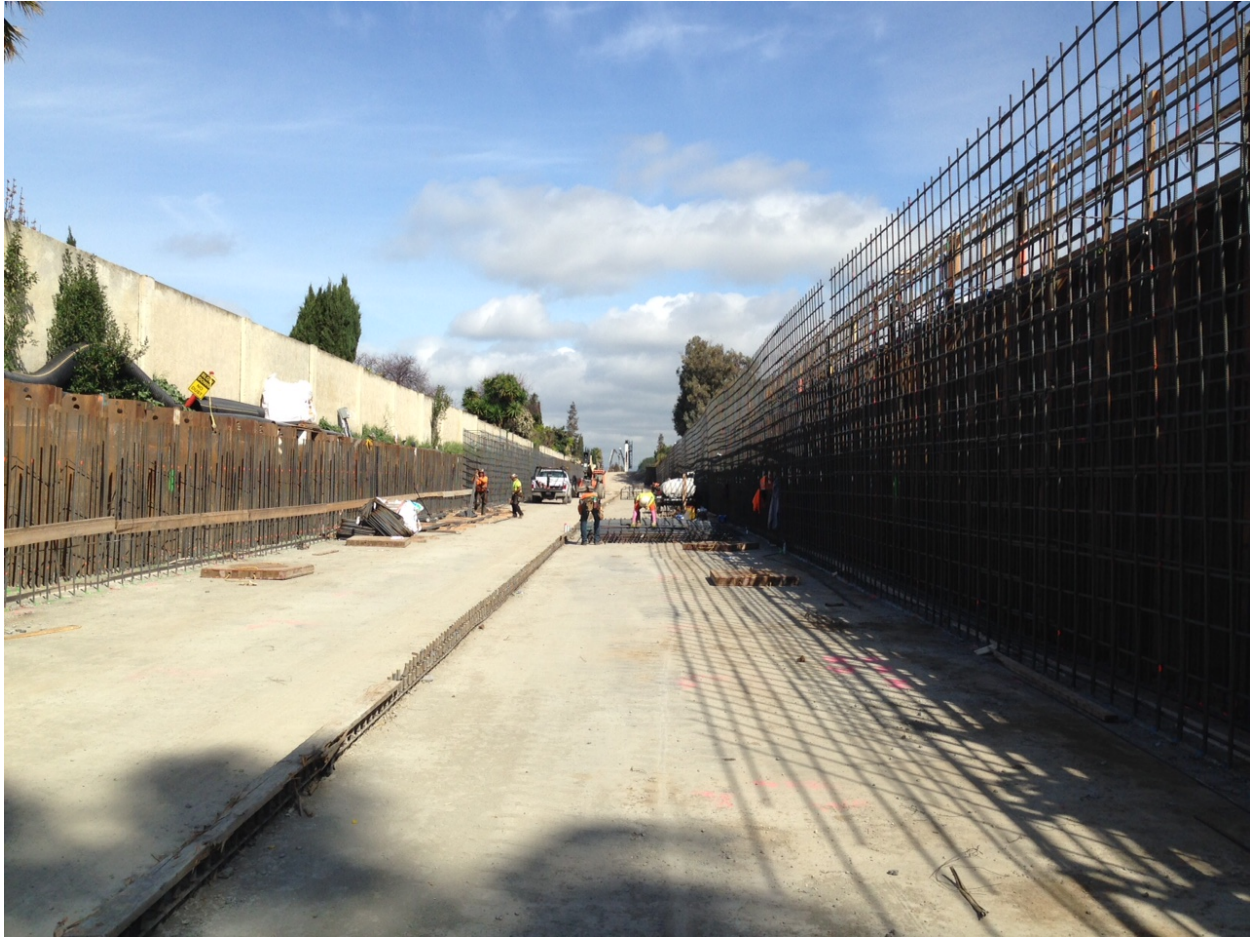
The center wall vertical rebars have couplers installed and the Contractor stated that impalement protection is not required. Is this a compliant condition?

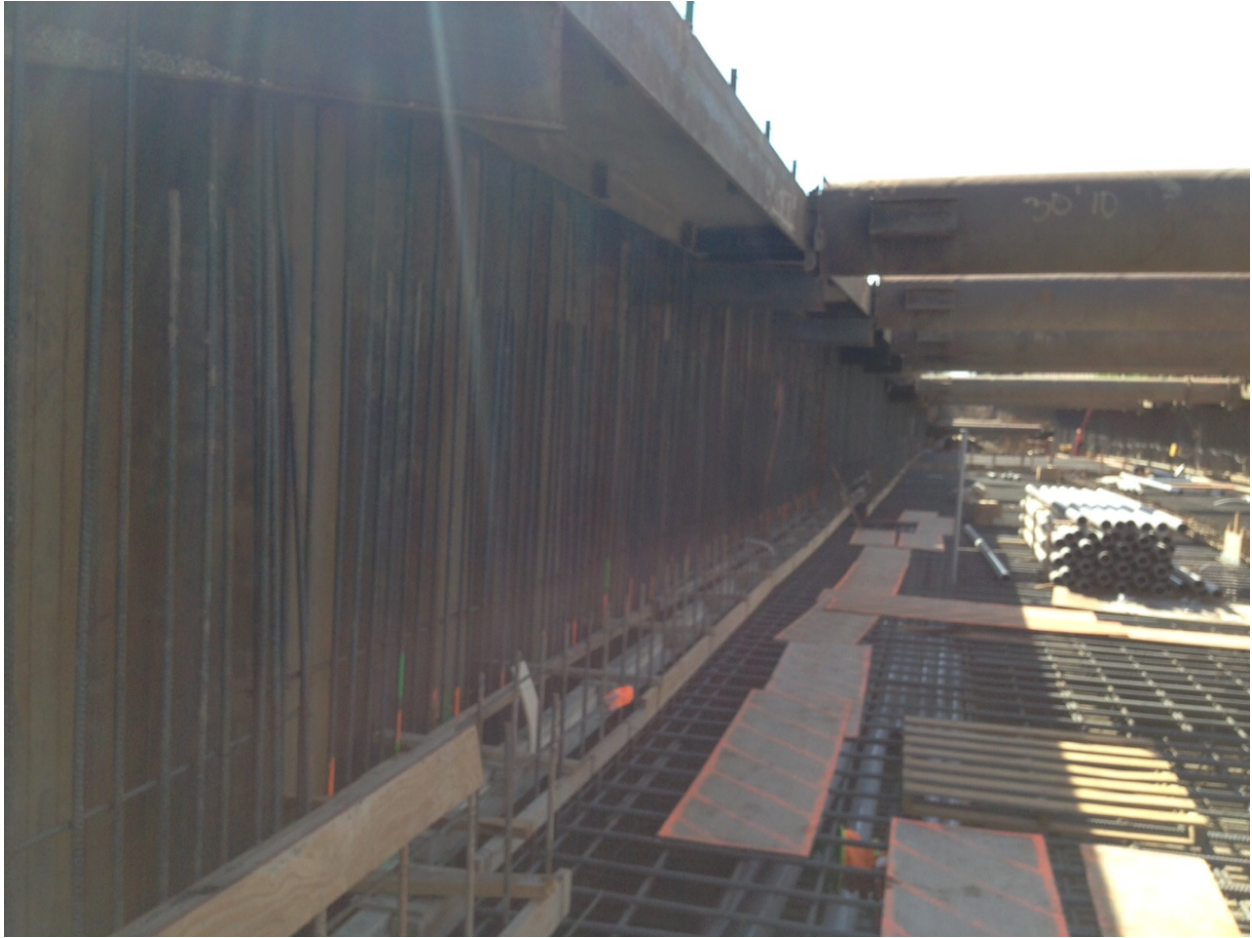
Another work area on the project where impalement protection has not been installed next to a temporary walkway.

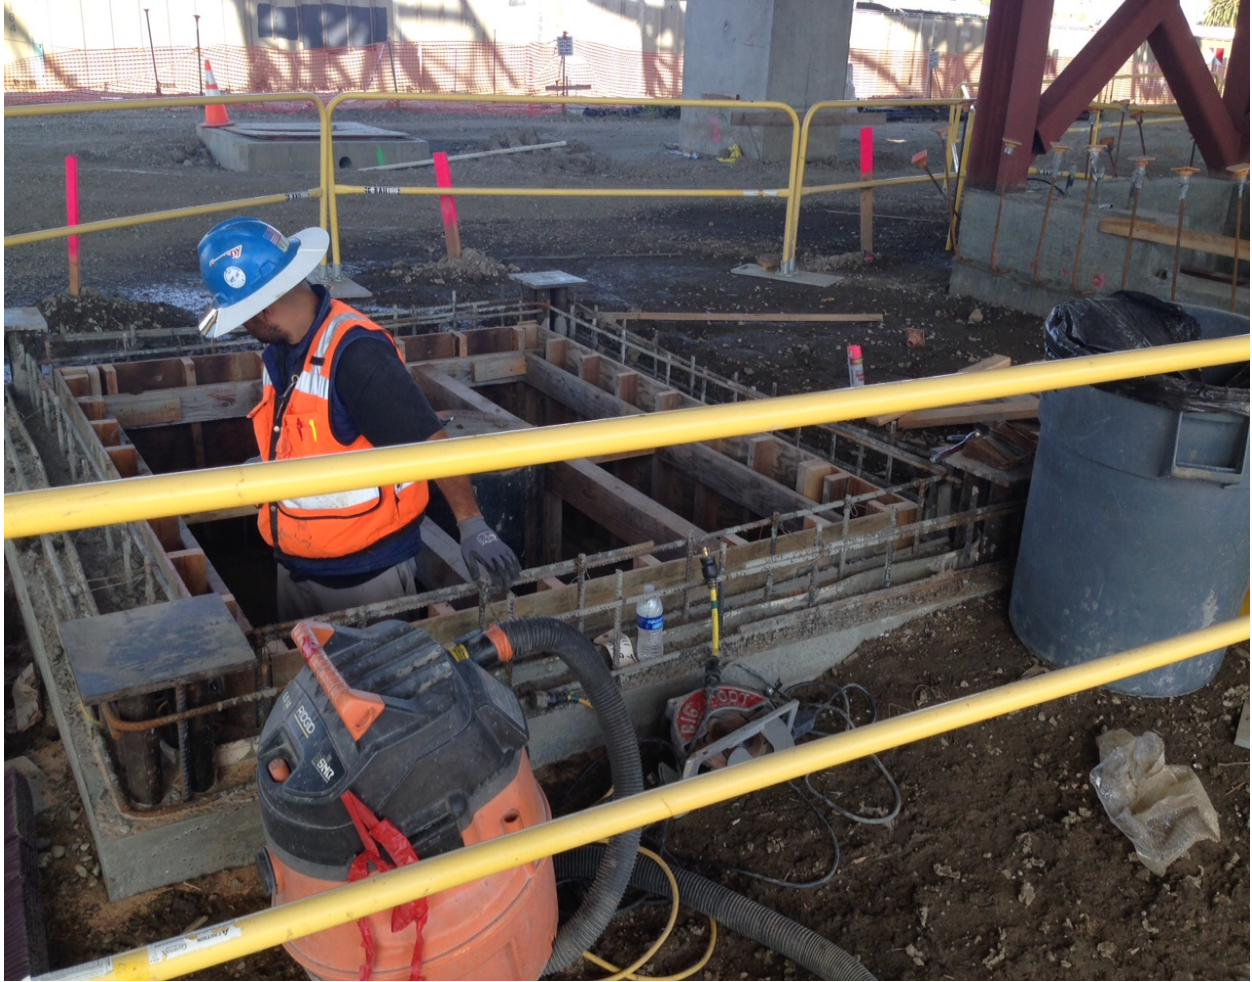
The worker in the photo is exposed to unprotected vertical rebars

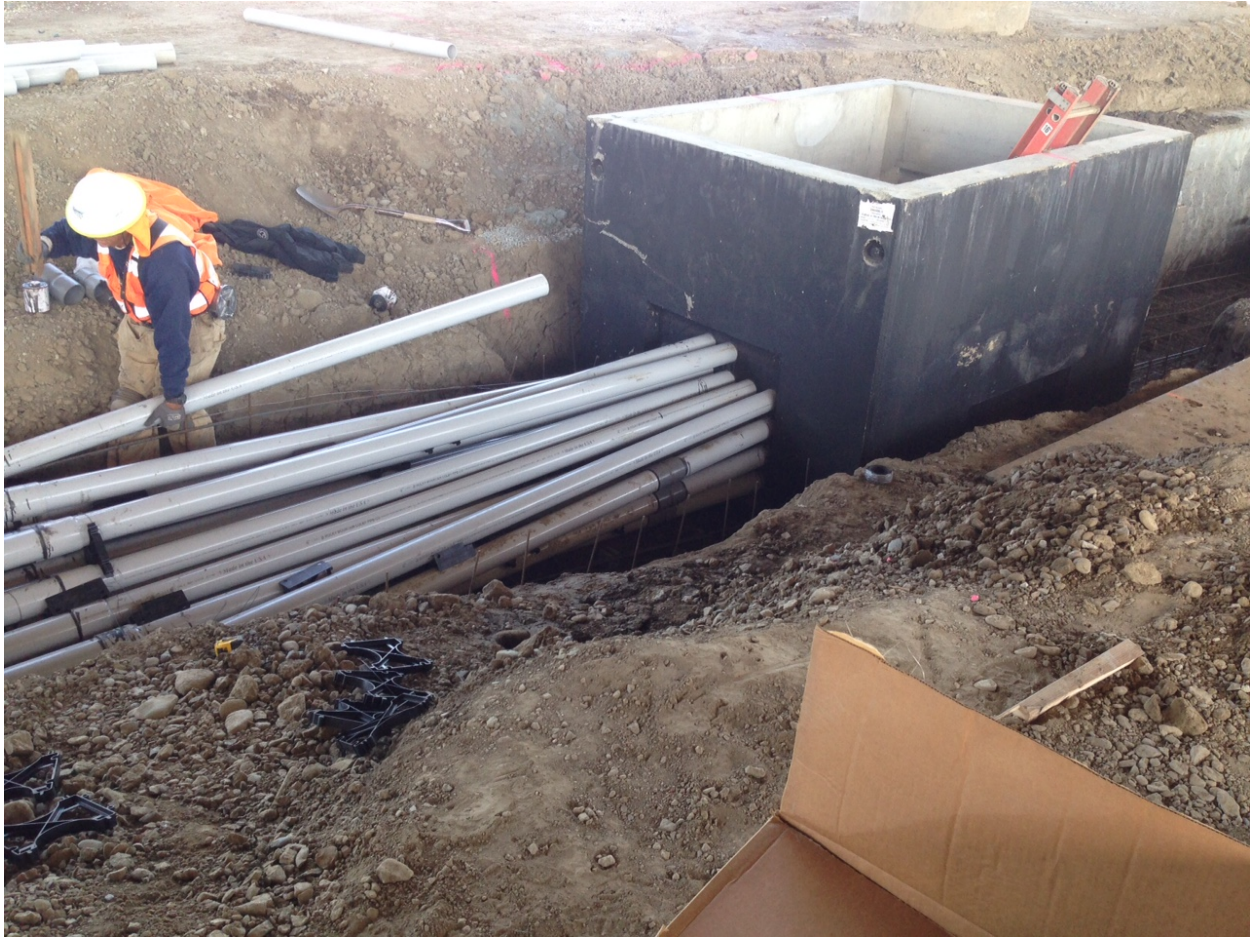
The underground electrical crew is exposed to impalement during the installation of underground electrical system.
